BURNED AREA EMERGENCY RESPONSE PLAN
2018 TERWILLIGER FIRE
ENGINEERING RESOURCE ASSESSMENT

I. OBJECTIVES

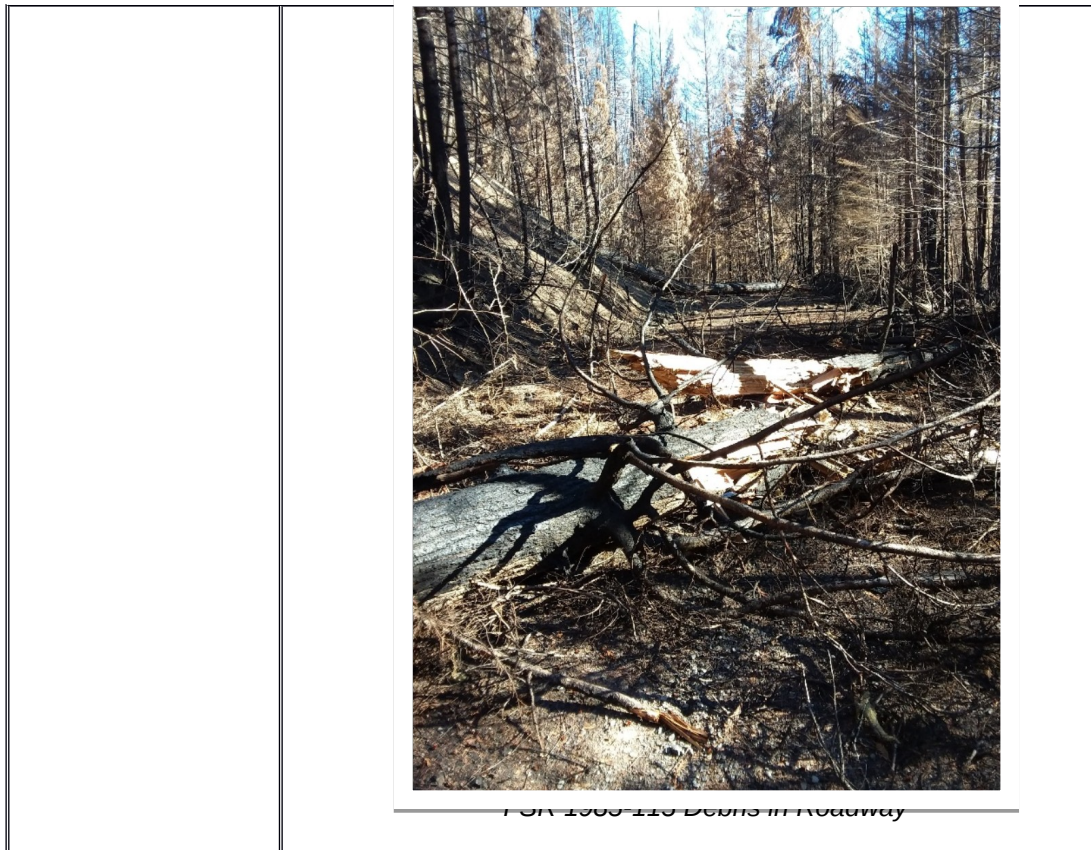
1985115

- ML 2 road accessing FS timber lands
- Portions in or above road in High or Moderate Soil Burn Severity.
- Stacked road above FSR 19 directly in high and moderate burn severity with several perennial drainage crossings (Boone and Rider Creek).
- Needs: road closure and storm inspections and response.
 - Critical values at risk (property)

Situation: FSR 1985-115 is a ML 2 road and has portions that are in High to Moderate Soil Burn Severity and has many danger trees and rock fall potential. Public travel on this road would be unsafe.

Recommendation: Close gate on FSR 1985-115.
